Handbook: 1. Structural Upgrading - Version 0.0

Process step: 2. RVS

Engineering Inspection Manual RVS

Building type: CC1b
NAM ref: EP201311204127

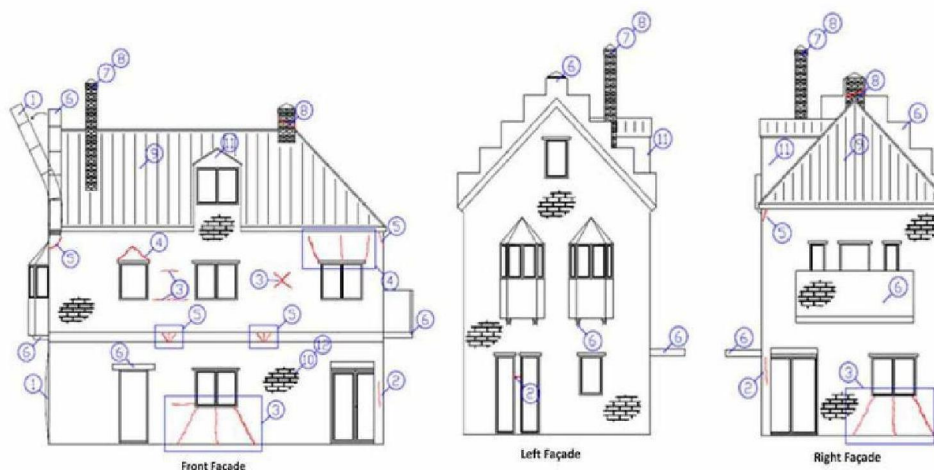
Figure 2 Overview of High Risk Building Elements (notional building).

Item	HRBE	section
1	Walls out of plane (bulging walls, out of plumb) Gables	3.4.1
2	Slender columns, cracked columns	3.4.2
3	Cracked or deformed walls	3.4.3
4	Cracked lintels/ spandrels	3.4.4
5	Lack of ties, punching elements	3.4.5
6	Parapets, balcony, etc.	3.4.6
7	Slender chimneys	3.4.7
8	Deformed or damaged chimneys	3.4.8
9	Missing roof cladding or loose bricks	3.4.9
10	Lack of mortar between bricks	3.4.10
11	Dormers of brick work	3.4.11
12	Lack of cavity ties	3.4.12
13	Other	3.4.13

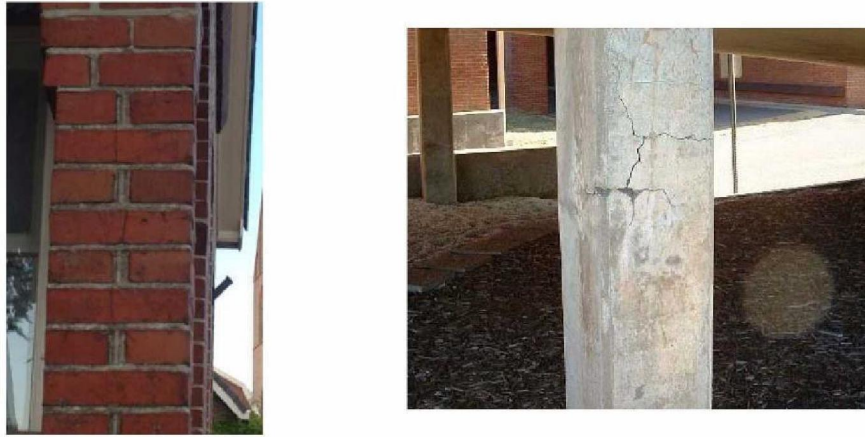
Figure 6 Cracks in concrete or masonry columns.

This item is to be selected when relevant cracks are seen in masonry or concrete columns. Figure 6 shows examples of general cracks for (reinforced) concrete columns and a vertical cracks in a masonry column.

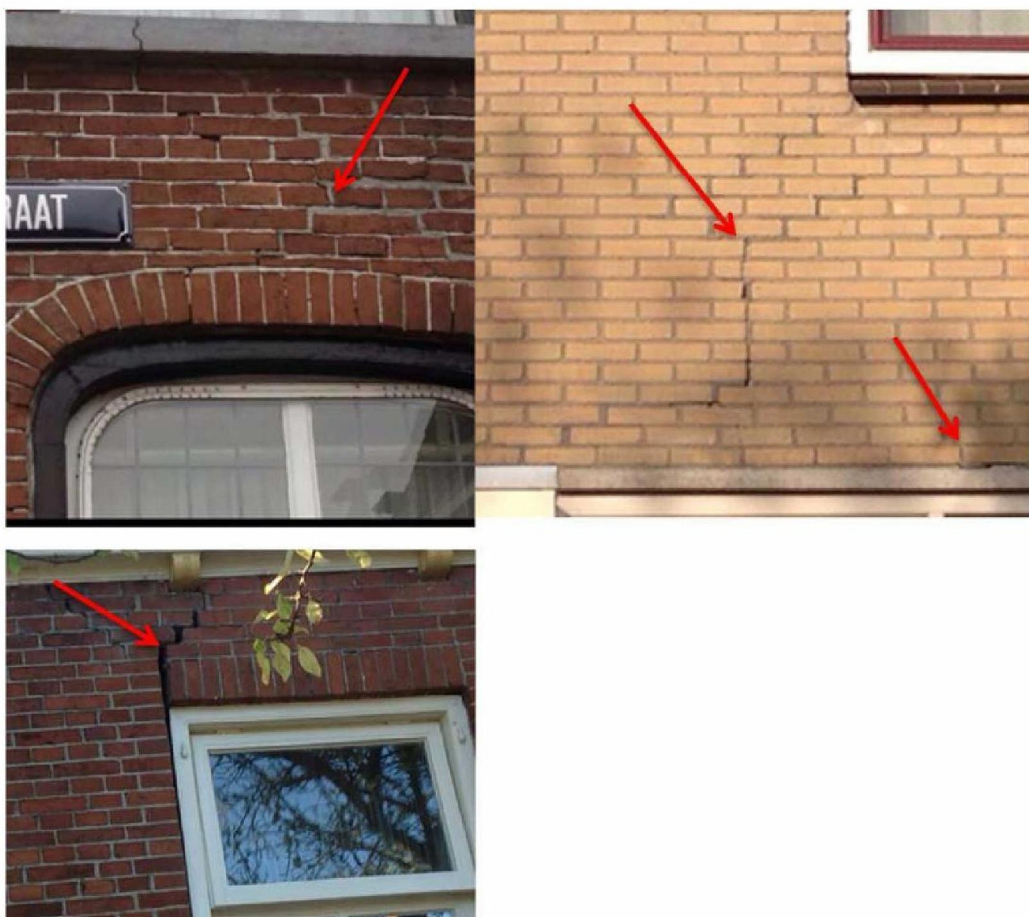
Figure 11 Examples of cracks in spandrels with or without lintels.

The cracks/deflections in the lintels may pose high loadings onto the window frames. It might be the case that only small deflections on these window frames are visible; in general it is not plausible to find collapsed frames. Further investigation will have to be completed to demonstrate that the situation is safe.

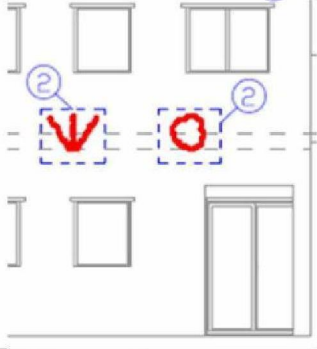
Crack case 2

Urgent Action	If the cracks are approx. > 5 mm) and a rotational mechanism has been triggered it is possible that part of the wall could collapse.
Further Investigation	If the cracks are between approx. 1-2 mm it is important to carry out more detailed inspection in order to assess the level of damage and to investigate the connections.
No Action	If the crack is categorised as hairline.

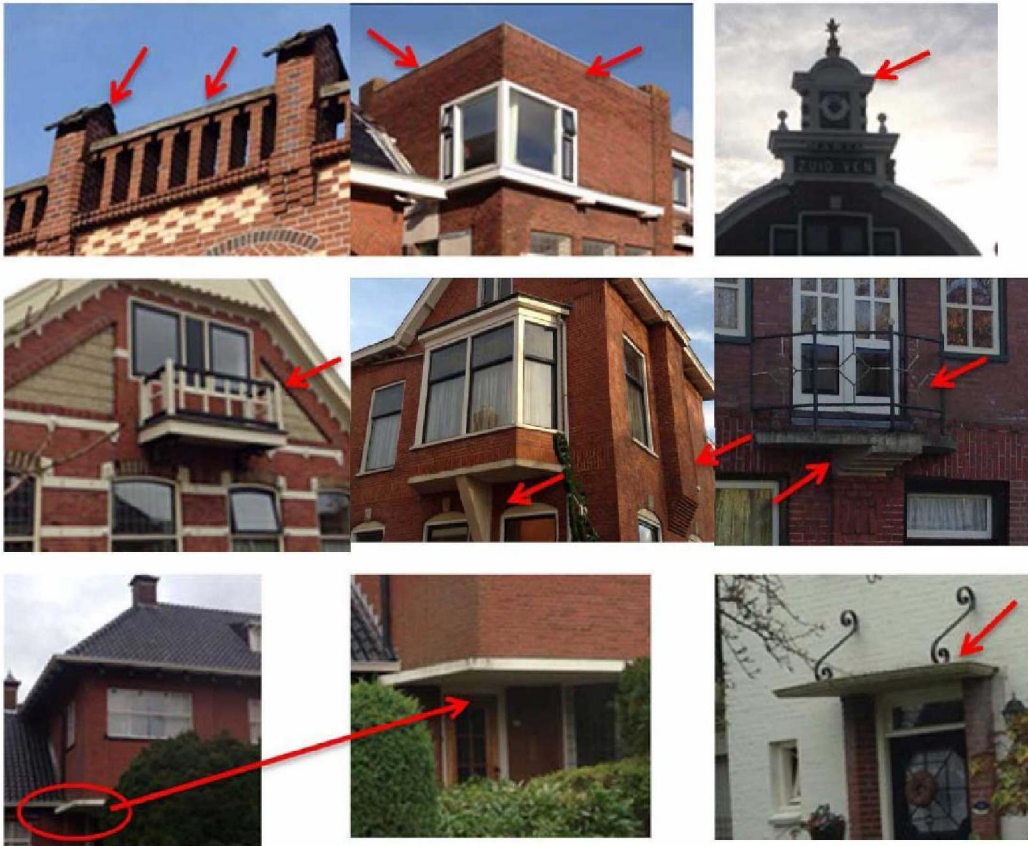
Figure 14 A few examples of parapets, balconies, cantilever or canopies (all potential falling hazards).

The elements mentioned above should be labelled as potential falling hazards. Apart from the collapse risk, the risk from detached masonry elements falling on people inside and also outside buildings should be reduced. It is noted that in both the Roermond (1992) and Christchurch (2011) earthquakes, the majority of casualties occurred to people outside buildings due to falling objects. A notable feature is that HRBE falling hazard failures typically occur at significantly lower levels of shaking than building collapse.

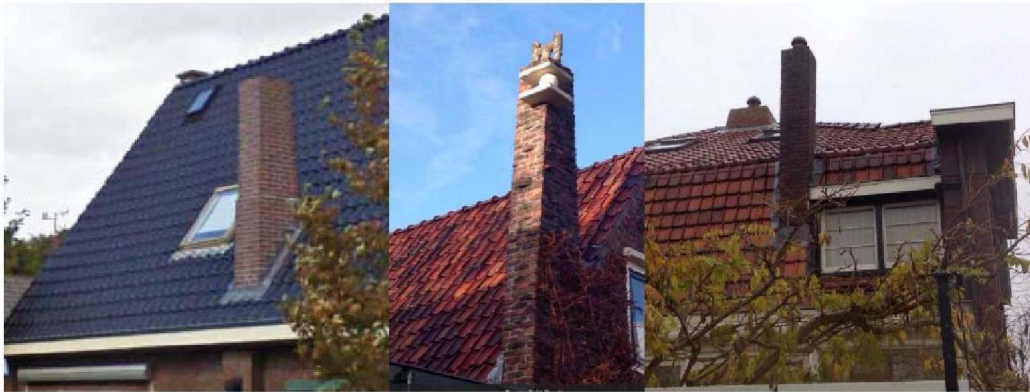
Figure 16 Examples of slender chimneys.

For examples of slender chimneys see Figure 16.

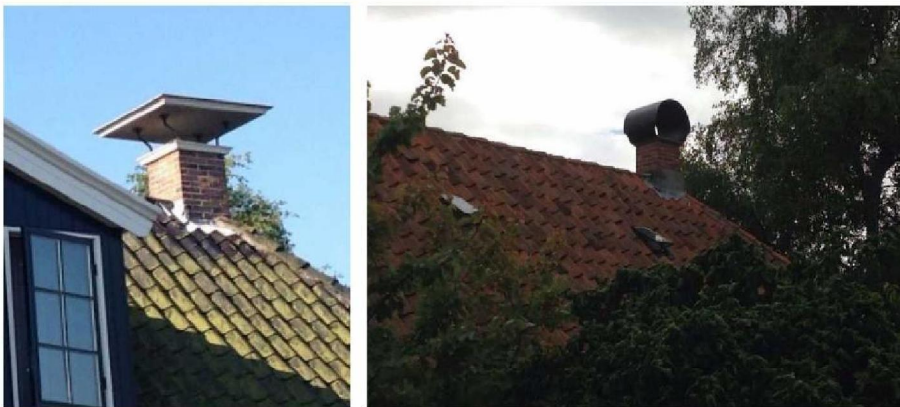
Figure 17 Example of chimneys with caps.

During the inspection of masonry chimneys caps of various types and materials can be found over masonry chimneys. These caps and ornaments are reasonably common in the Groningen region. See Figure 17 and Figure 18 for examples.

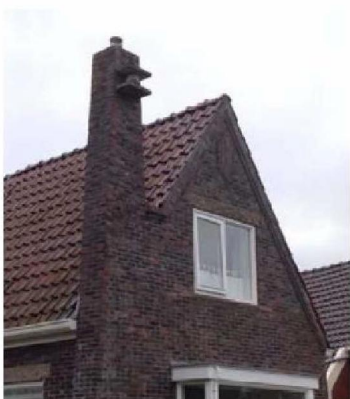
Figure 18 Example of a chimney with ornament.

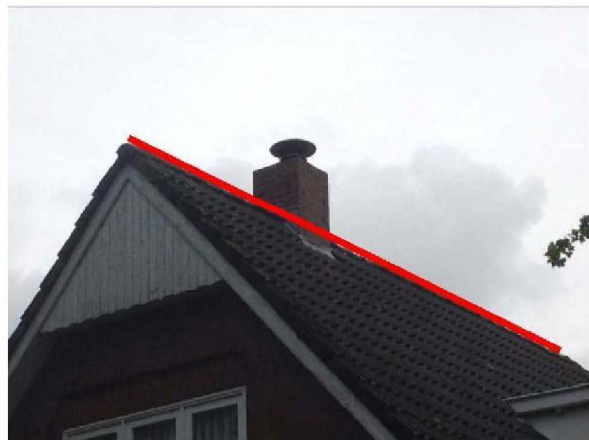
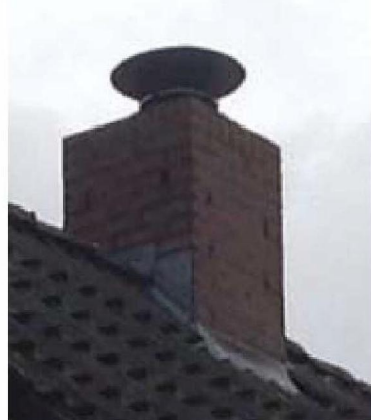
Figure 20 Example of a chimney likely to be supported by timber beams; No (or negligible) deflection of the roof structure visible and no damage visible on chimney.

Recommendation**A - Chimney (fully) supported by timber beams**

In the case of a chimney most likely supported by timber beams, where no visible damage is observed to the chimney and where no deflection is visible on the supporting roof structure, no further action is required. However, where damage and/or deflection is observed, then further investigation must be proposed as the final recommendation.

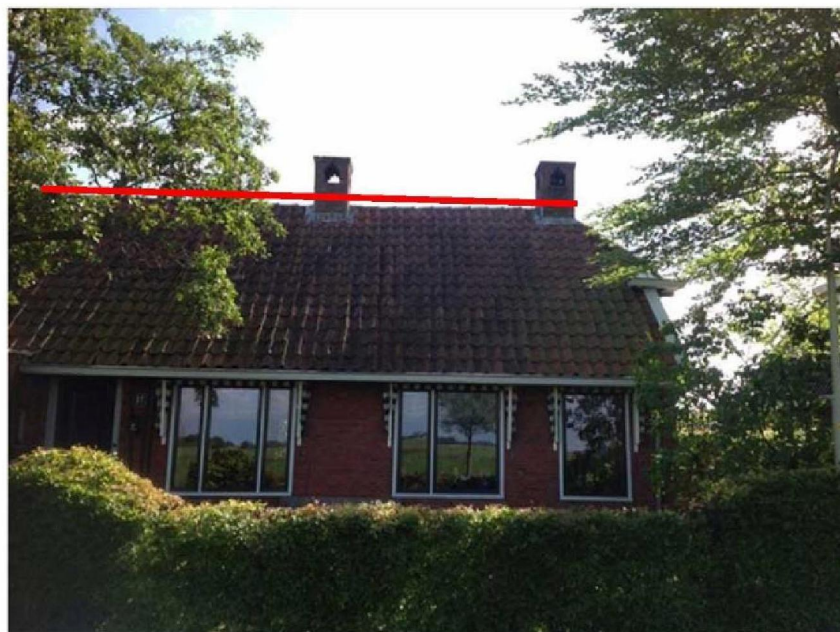
Figure 21 Example of a chimney likely to be supported by timber beams, with some deflection of the roof structure visible and no damage visible on chimney.

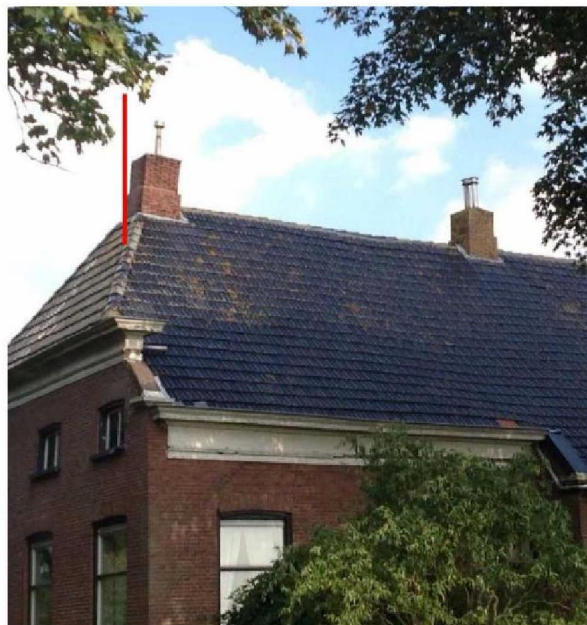
Figure 22 Example of a skew standing chimney likely to be supported by timber beams.

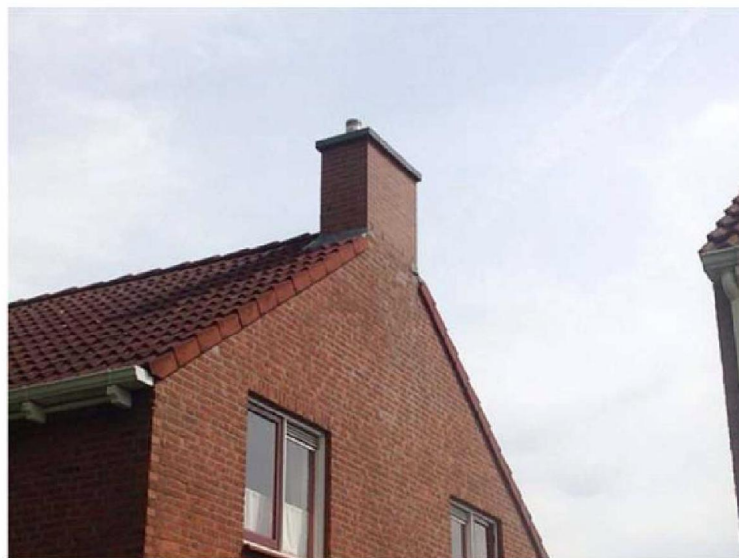
Figure 23 Example of a chimney partly supported by timber beams, with damage (horizontal cracks) of the masonry.

B - Chimney partly supported by timber beams

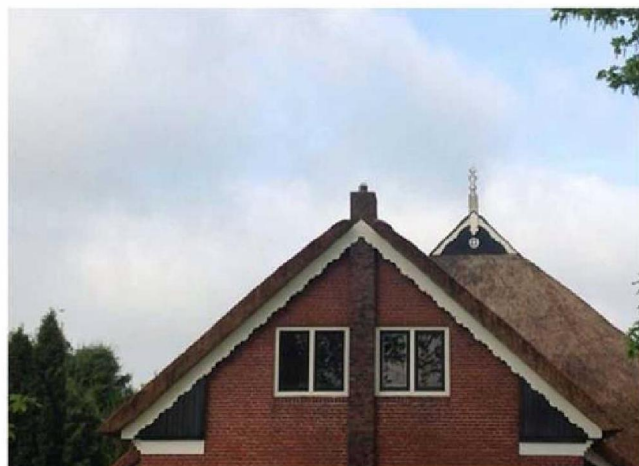
Figure 24 Example of a chimney supported by masonry flue, with no damage or deflection of the roof structure visible and no damage visible in the masonry channel.

In the case of a chimney supported by masonry flue where no damage is visible on the chimney and no deflection or damage to the supporting roof structure (and the supporting masonry) is visible, then no further action is proposed as final recommendation.

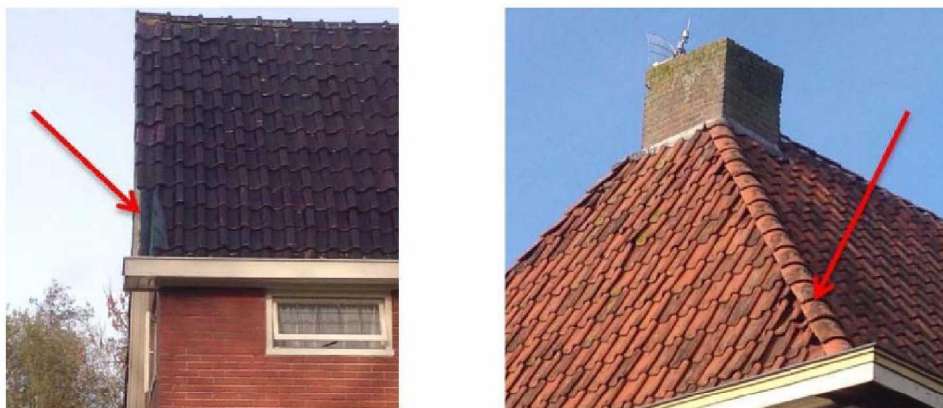
Figure 25 Examples of missing or loose roof tiles.

The inspectors must confirm that the roof cladding is in good condition. Missing, damaged, unstable or unsafe roof cladding should be reported as HRBE 9 (Figure 25).

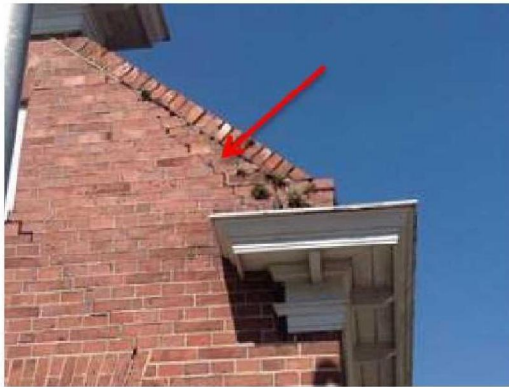
Figure 26 Example of loose bricks on gable walls.

The inspectors also should identify loose bricks on gable walls. These unstable bricks form a risk of falling and should be reported as HRBE 9 (Figure 26).

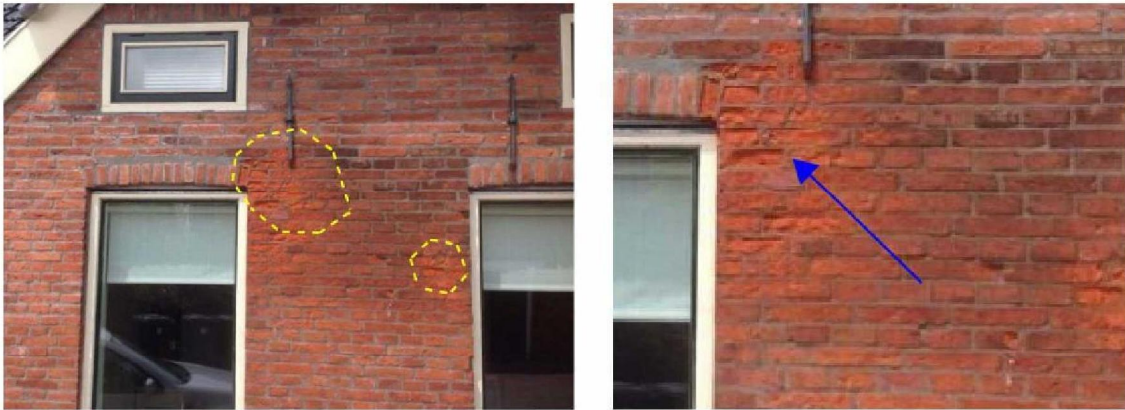
Figure 27 Masonry deterioration. Most of times it appears locally as shown on the picture.

During repointing of the mortar joints, damage on the masonry skin can appear (Figure 27). Most of times this damage is because of the differences in stiffness of the several used types of materials. A situation can be that the material of the mortar joint is stiffer than the bricks. The mortar joint(s) expands and when the stiffness of the brick is lower than the stiffness of the joint, the skin of the masonry can collapse/fall off (delaminate).

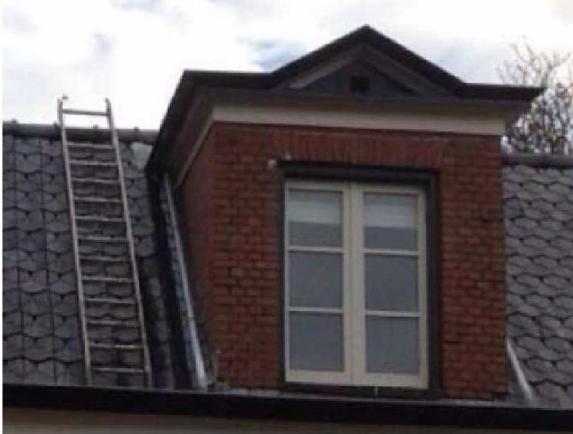
Figure 28 An example of masonry dormer.

A dormer can be identified as a HRBE if it is made of masonry. It is also possible that masonry dormers with an out of plane failure mechanism are found.

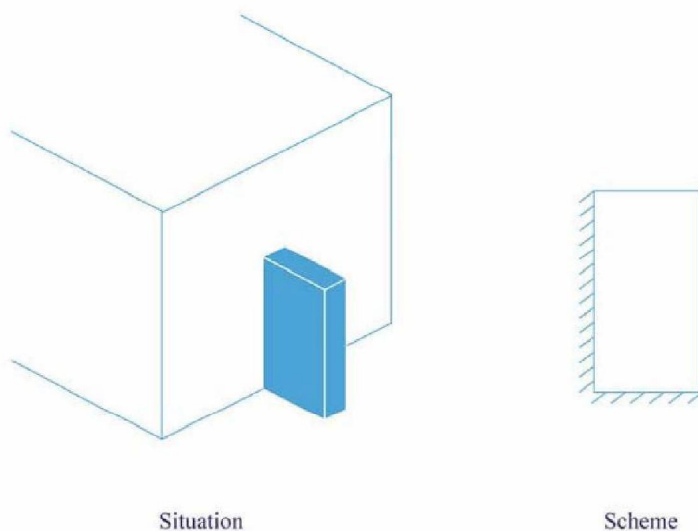
Figure 29 Masonry wall element.

For example: masonry cantilevered (vertical) wall elements (see figure 31), which could be found connected to buildings should be reported as “HRBE 13”, since they pose an adverse effect on the behaviour of the wall it is connected to during a seismic event. Instead of identify these as “Parapets” or “Cantilevered Elements (vertical cantilevered elements)”, to avoid confusion it is advised to put those elements at HRBE 13 “Other”.

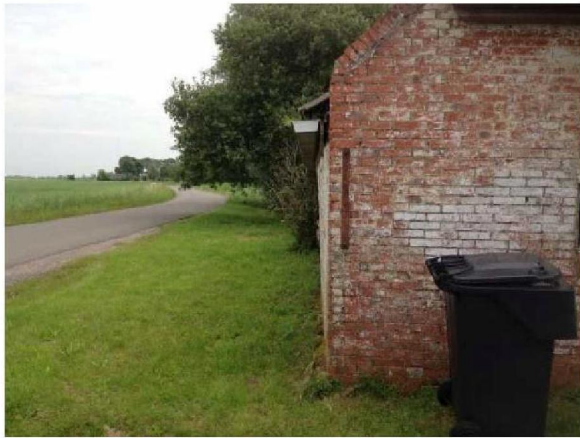
Walls out of plumb

<i>Walls out of plumb</i>	✓	Further investigation
<i>Bulging wall</i>	x	-
<i>Gable wall</i>	x	-

Data Characteristics:
If a wall leans inwards or outwards, we should report it as an out of plumb wall.

Engineer Comment to inspector:
Assess each façades separately, each façade should have comments about estimated geometric deviations and observed damage. Common reasons for this type of damage are: problems in roof construction or lack of floor/wall connections.

This is **not a bulging wall**; we should consider the vertical cross section. In this situation the wall is out of plumb with a maximum deviation at the top of the wall in correspondence of the wall middle horizontal section.

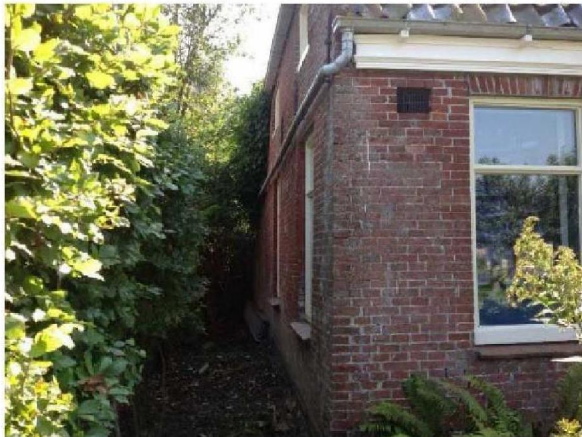
Bulging wall

<i>Walls out of plumb</i>	x	-
<i>Bulging wall</i>	✓	Further investigation
<i>Gable wall</i>	x	-

Assess each facades separately, each façade should have comments about estimated geometric deviations and observed damage.

Common reasons for this type of damage are; bearing, movement in the building (pushing elements), lack of wall to floor connections, a possible foundation issues.

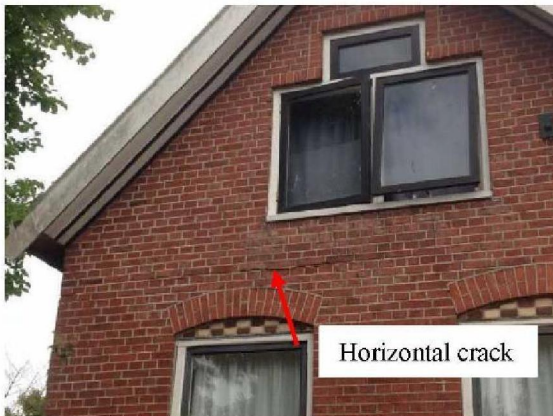
Gable wall

<i>Walls out of plumb</i>	x	-
<i>Bulging wall</i>	x	-
<i>Gable wall</i>	√	Further investigation

If a gable wall is showing signs of a rotational mechanism, horizontal cracks along the gable and/or deviation, should be reported as HRBE (gable wall).

Horizontal crack observed at the front gable near floor level. No deformation observed.

Assess each gable wall separately, each gable wall with visible issues (as above) should be reported with comments about estimated geometric deformations and observed damage.

Common reasons for this type of damage are: lack of connection between roof/gable, lack of wall ties.

Vertical cracks, which are formed between the gable and the roof, are other indicators of detachment of the gable.

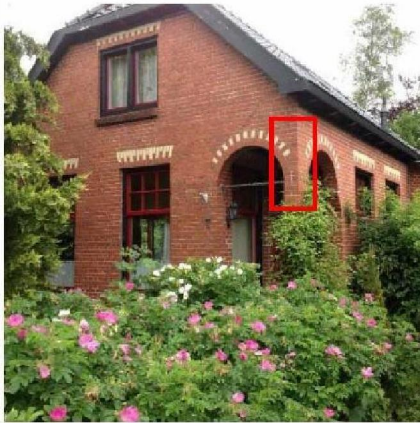
Slender columns or cracks in concrete/masonry columns

Crack

Masonry column, horizontal cracked near connection tie bar. Also cracks observed near the arch.

Comment should be made about the material and the presence of damage. It is not required to make a comment about the slenderness. In this situation the combination of horizontal crack in column and cracked arch require urgent action.

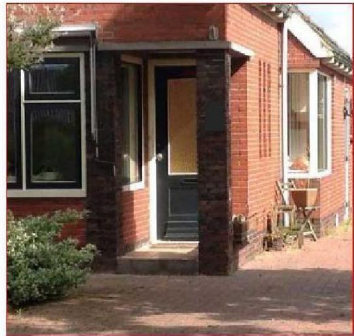
Structural slender, undamaged column

Structural masonry column, no damage observed.

Comment should be made about the material and the presence of damage. It is not required to make a comment about the slenderness.

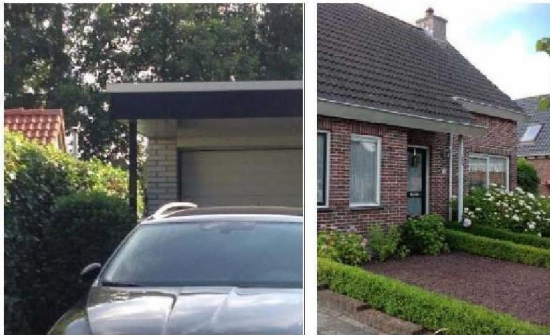
Post supporting canopy

Slender columns or cracks in concrete/masonry columns **x** -

Data Characteristics:
Post supporting the canopy.

Engineer Comment to inspector:
The post only supports the canopy and should be reported as HRBE 6 canopy.

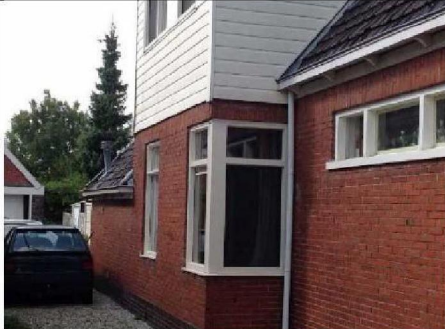
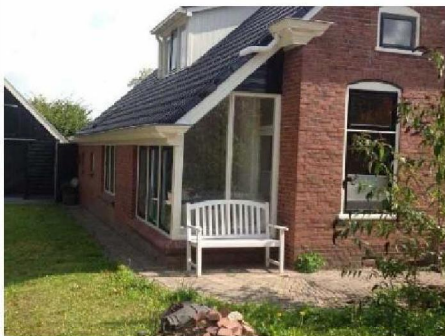
Slender columns or cracks in concrete/masonry columns **x** -

Data Characteristics:
Timber post at corner window

Engineer Comment to inspector:
The corner timber post is not to be considered as a column and doesn't have to be reported as HRBE unless they extend a full storey and/or appear to support a significant load and/or appear damaged/cracked.

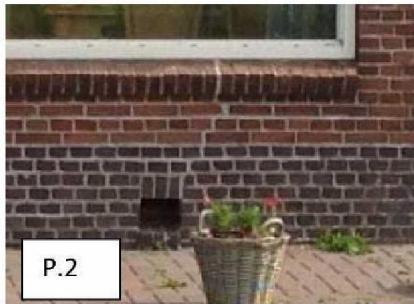
Wall cracks

<i>Wall cracks</i>	✓	No Action
<p><i>Data Characteristics:</i> If there is damage present in the form of cracks in masonry this should be reported as HRBE 3. The recommendation depends on the deformation and damage. <u>No action:</u> The crack is categorized as a local hairline (P.1) or the crack(s) have been sealed (P.2). The damage or repair work which is present is likely to be not severe enough to need further investigation. <u>Further investigation:</u> Generally relevant structural cracks or a large amount of sealed damage can be reported as further investigation. <u>Urgent action:</u> When the width of the crack is significant (>approx. 5 mm) and/or the element is quite deformed, an “Urgent Action” is required. Also when one or more cracks are present which compromise the safety of the entire building or a part of the building.</p>		
<p><i>Inspector Comment:</i> P1: Hairline crack(s) observed, P2: Observed cracks/joints have been sealed.</p>

<p><i>Engineer Comment to inspector:</i> P1: The observed damage is assumed to be not significant. P2: Because of the low amount or not significant location of the observed damage, it is assumed to be not significant.</p>

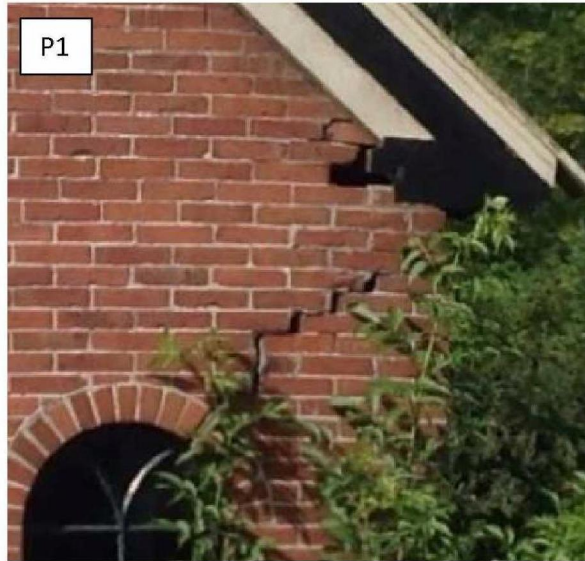
Wall cracks

Severe crack observed in the front façade in combination with out of plane movement of the right façade.

A detailed description of encountered situation should be given. The cause of cracks can be; soil subsidence, horizontal actions, overloading, lack of robustness of wall constrains, others.

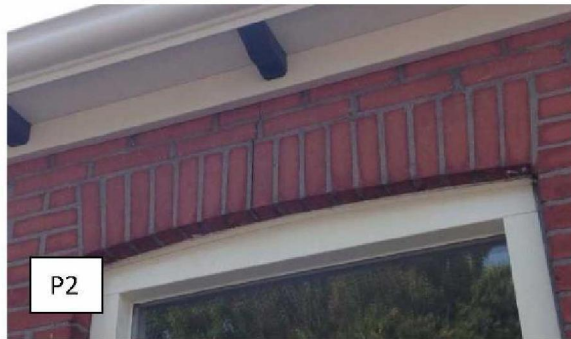
Deflected/cracked lintel/spandrel

<i>Deflected or cracked lintel/spandrels</i>	✓	Further investigation
<p><i>Data Characteristics:</i> Signs of damage observed in spandrels (above openings) and lintels. The recommendation depends on the deformation and/or damage. <u>No action:</u> The crack is categorized as a hairline or the crack(s) have been sealed. The damage or repair work which is present is likely to be not severe enough to need further investigation. <u>Further investigation:</u> If inspectors identify deflection (P1) or some cracks in spandrels above openings or in lintels (P2) this should be reported as further investigation <u>Urgent action:</u> When the width of the crack is significant (>approx. 5 mm) and/or the element is quite deformed, an “Urgent Action” is required. Also when one or more cracks are present which compromise the safety of the entire building or a part of the building.</p>		
<p><i>Inspector Comment:</i> P1: Sealed joints in lintel observed. P2: No comment required (in case of general structural cracks).</p>

<p><i>Engineer Comment to inspector:</i> When there are a large amount of repaired lintels observed this could be an indication of high vulnerability.</p>

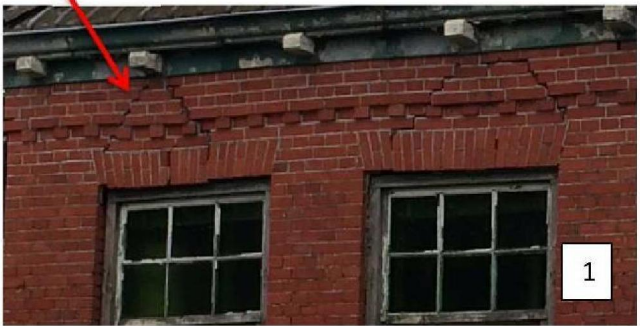
Deflected/cracked lintel/spandrel

<i>Deflected or cracked lintel/spandrels</i>	✓ Urgent action
	Data Characteristics: Signs of damage observed in spandrels (above openings) and lintels. The recommendation depends on the deformation and/or damage.	
	<u>No action:</u> The crack is categorized as a hairline or the crack(s) have been sealed. The damage or repair work which is present is likely to be not severe enough to need further investigation.	
	<u>Further investigation:</u> If inspectors identify deflection or some cracks in spandrels above openings or in lintels and or this should be reported as further investigation.	
<u>Urgent action:</u> When the width of the crack is significant (>approx. 5 mm) and/or the element is quite deformed, an “Urgent Action” is required. Also an urgent action may be justified when one or more cracks are present which compromise the safety of a larger part of the building or to people below (P1).

<i>Inspector Comment:</i> Severe deformation and cracks observed above the windows of the front façade.		
<i>Engineer Comment to inspector:</i> A detailed description of encountered situation should be given.

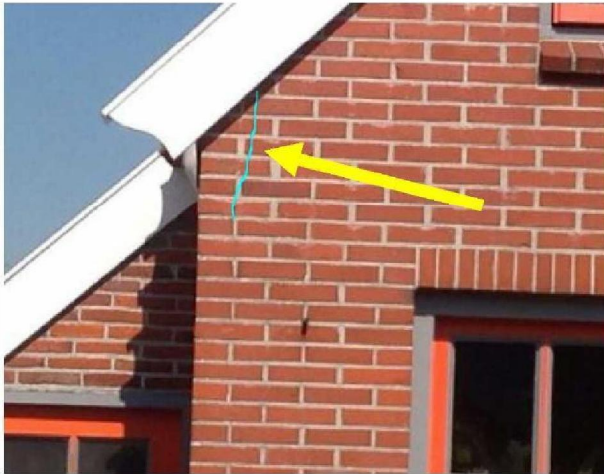
Wall damage caused by lack of wall-floor-roof ties

“Typical cracks for HRBE 5 (pushing elements from for example the Roof structure).”

Wall damaged because of (assumed) lack of ties (floor connections), walls damaged because of pushing elements (roof, floor etc.). It is possible that some out-of-plane movement might also be observed here.

Relevant crack(s), located at the left top corner of the front façade, have been observed and require further investigation.

Always make clear descriptions of the exact location of the damage been observed.

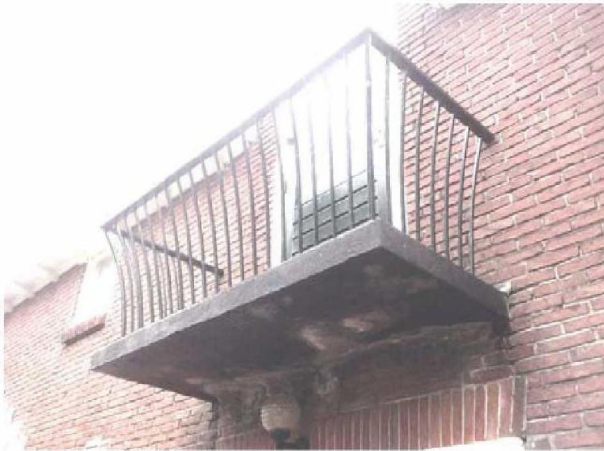
**Parapet(s)-Balcony(s)-
Cantilevered Element(s)-
Canopy(s)**

Example of scheme for a balcony, cantilever or canopy.

No action: The observed balcony is not slender ($L/h < 1,5$) or damaged.

Further investigation: The structural support system is not clear, there could be a slenderness issue ($L/h > 1,5$) and the degradation of the building materials needs to be looked at more closely.

Urgent action: When cracks are observed in (masonry or) reinforced concrete balcony (near the intersection with the wall), when the (L/h) ratio is clearly exceeding the limit (slenderness issue) or when the degradation of the building materials needs to be looked at more closely (steel corrosion, cracks and corrosion in reinforced concrete slabs).

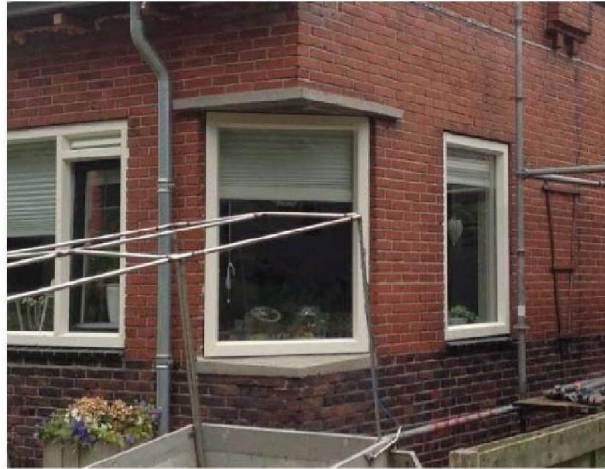
**Parapet(s)-Balcony(s)-
Cantilevered Element(s)-
Canopy(s)**

Cantilevered Element(s) ✓ Further investigation

No action: The observed balcony is not slender ($L/h < 1,5$) or damaged.

Further investigation: The structural support system is not clear, there could be a slenderness issue ($L/h > 1,5$) and the degradation of the building materials needs to be looked at more closely.

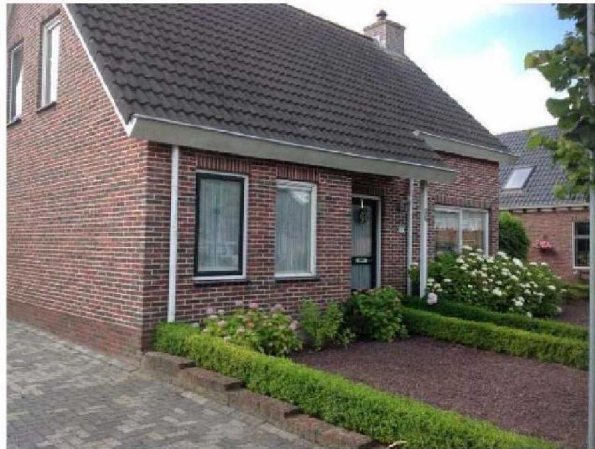
**Parapet(s)-Balcony(s)-
Cantilevered Element(s)-
Canopy(s)**

<i>Canopy(s)</i>	✓	No action
<p><i>Data Characteristics:</i> Canopies (overhead roof able to provide shade or shelter) are secondary structural elements which are typically supported by columns/ brackets or cantilevers (only supported on one side). When the ratio $L/h > 2,0$ (canopy) the slenderness should be evaluated. When $L/h > 5$, this element could be an issue under seismic load The recommendation depends on the deviation and damage. <u>No action:</u> the observed canopy is not slender ($L/h < 2,0$) or damaged. <u>Further investigation:</u> structural support system is not clear, there could be a slenderness issue ($L/h > 2,0$) or the maintenance level needs to be looked more closely. <u>Urgent action:</u> when cracks are observed in (masonry or) reinforced concrete canopies (near the intersection with the wall), when the L/h ratio is clearly exceeding the limit (slenderness issue) or when the maintenance level is clearly bad (steel corrosion, cracks and corrosion in reinforced concrete slabs).</p>

<p><i>Inspector Comment:</i> The front canopy is part of the building roof structure above the entrance. No damage or deflection observed.</p>		
<p><i>Engineer Comment to inspector:</i> Self-supporting canopy. Slenderness is not a criteria in this situation because the canopy is not cantilevering from a fixed restraint but it has a large back span.</p>

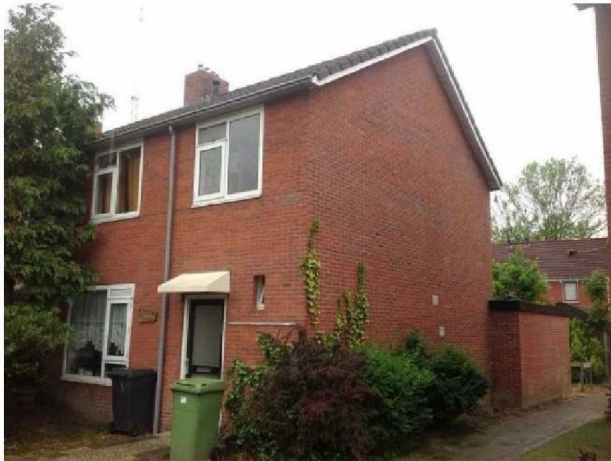
**Parapet(s)-Balcony(s)-
Cantilevered Element(s)-
Canopy(s)**

<i>Canopy(s)</i>	✓	No action
<p><i>Data Characteristics:</i> Canopies (overhead roof able to provide shade or shelter) are secondary structural elements which are typically supported by columns/ brackets or cantilevers (only supported on one side). When the ratio $L/h > 2,0$ (canopy) the slenderness should be evaluated. When $L/h > 5$, this element could be an issue under seismic load. The recommendation depends on the deviation and damage. No action: the observed canopy is not damaged. <u>Further investigation:</u> structural support system is not clear, there could be a slenderness issue ($L/h > 2,0$) or the maintenance level needs to be looked more closely. <u>Urgent action:</u> when cracks are observed in (masonry or) reinforced concrete canopies (near the intersection with the wall), when the L/h ratio is clearly exceeding the limit (slenderness issue) or when the maintenance level is clearly bad (steel corrosion, cracks and corrosion in reinforced concrete slabs).</p>

<p><i>Inspector Comment:</i> Light weigh canopy without damage or deflection observed.</p>		
<p><i>Engineer Comment to inspector:</i> Because the canopy is light weight no further investigation is needed. As a rule of thumb, if the weight $< 0.5 \text{ kN/m}^2$ the frame could be considered light weight construction.</p>

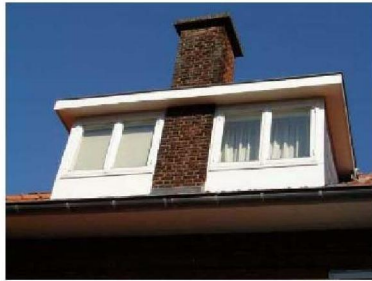
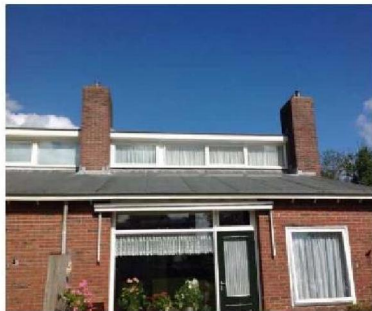
From where to measure?

Slender chimney ✓ Further investigation

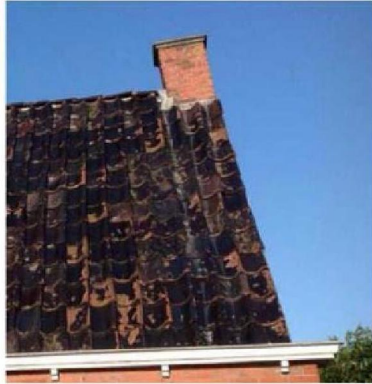
Chimneys with deformed and/or rotated shape

<i>Deformed chimney</i>	x	-
<i>Rotated chimney</i>	x	-
<i>Chimney standing skew</i>	√	Further investigation
<i>Wood supported</i>		
<i>Data Characteristics:</i> Chimneys are classified as a high risk building element when they are damaged in a way that could increase the falling hazard due to horizontal actions.		
<i>Recommendation:</i> <u>No action:</u> If there is minor or no damage/deformation/rotation observed to the chimney. <u>Further investigation:</u> If the chimney is deformed, rotated or otherwise damaged. <u>Urgent action:</u> When chimneys have a severely deformed/rotated shape and/or they are clearly heavily damaged.		
<i>Inspector Comment:</i> Chimney is leaning to the left side. Ratio 1.5-2		
<i>Engineer Comment to inspector:</i> -

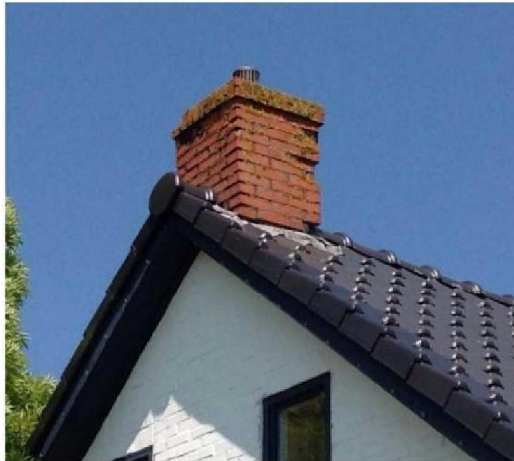
Chimneys with deformed and/or rotated shape

<i>Deformed chimney</i>	✓	Further investigation
<i>Rotated chimney</i>	x	-
<i>Chimney standing skew</i>	x	-
<i>Wood supported</i>		
<i>Data Characteristics:</i> Chimneys are classified as a high risk building element when they are damaged in a way that could increase the falling hazard due to horizontal actions.		
<i>Recommendation:</i> <u>No action:</u> If there is minor or no damage/deformation/rotation observed to the chimney. <u>Further investigation:</u> If the chimney is deformed, rotated or otherwise damaged. <u>Urgent action:</u> When chimneys have a severely deformed/rotated shape and/or they are clearly heavily damaged.		
<i>Inspector Comment:</i> Deformation and damage observed. Ratio 1.5-2		
<i>Engineer Comment to inspector:</i> -

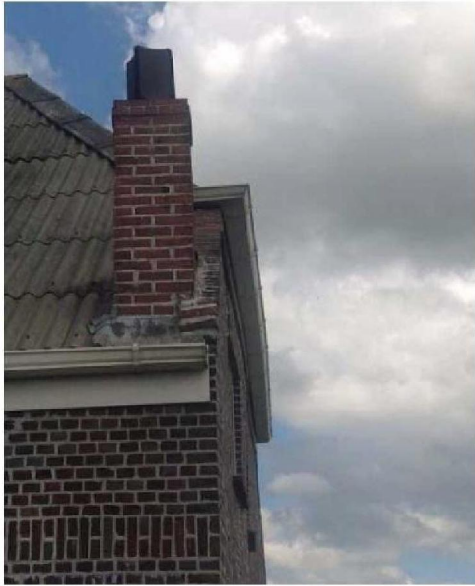
Chimneys with deformed and/or rotated shape

<i>Deformed chimney</i>	x	-
<i>Rotated chimney</i>	√	Further investigation
<i>Chimney standing skew</i>	x	-
<i>Wood supported</i>		
<i>Data Characteristics:</i> Chimneys are classified as a high risk building element when they are damaged in a way that could increase the falling hazard due to horizontal actions.		
<i>Recommendation:</i> <u>No action:</u> If there is minor or no damage/deformation/rotation observed to the chimney. <u>Further investigation:</u> If the chimney is deformed, rotated or otherwise damaged. <u>Urgent action:</u> When chimneys have a severely deformed/rotated shape and/or they are clearly heavily damaged.		
<i>Inspector Comment:</i> -		
<i>Engineer Comment to inspector:</i> Make a comment on the damage observed. A comment about the ratio of the chimney should also be added.

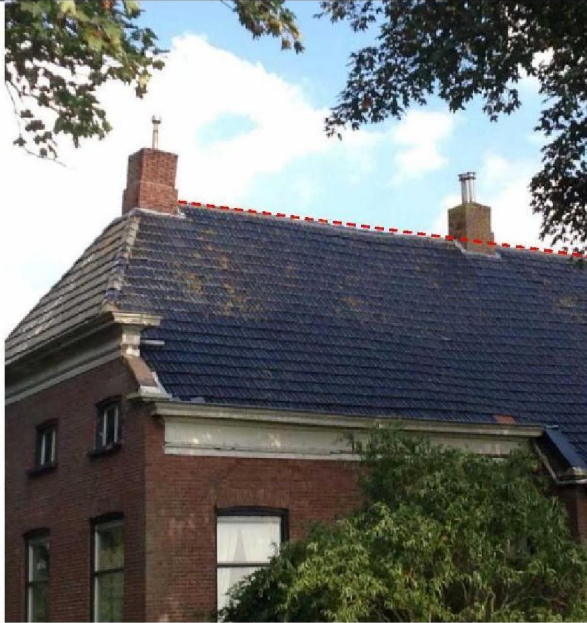
Roof deformation near chimneys

<i>Deformed chimney</i>	x	-
<i>Rotated chimney</i>	x	-
<i>Chimney standing skew</i>	√	Further investigation
<i>Wood supported</i>	x

Data Characteristics:
 Roof deformation can be affecting the chimney if the chimney is supported by wooden beams. If roof deformation is observed which compromises the support of the chimney, this should be reported by HRBE8.

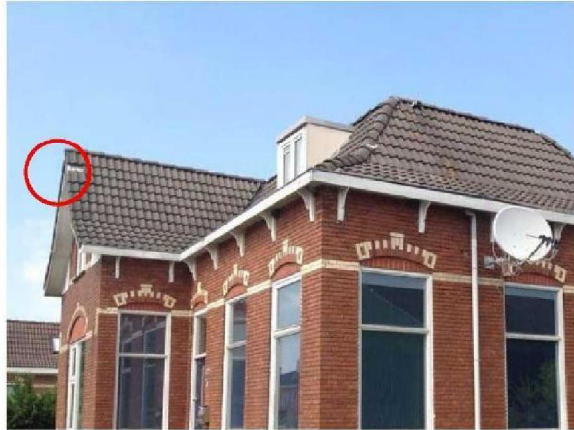
Unsafe roof cladding ✓ No action (not relevant)

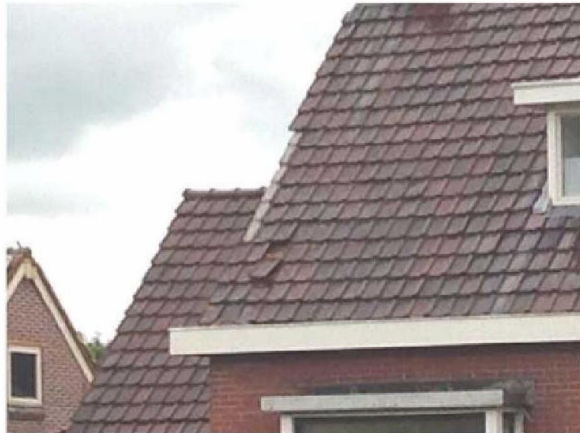
Unsafe roof cladding ✓ No action (relevant)

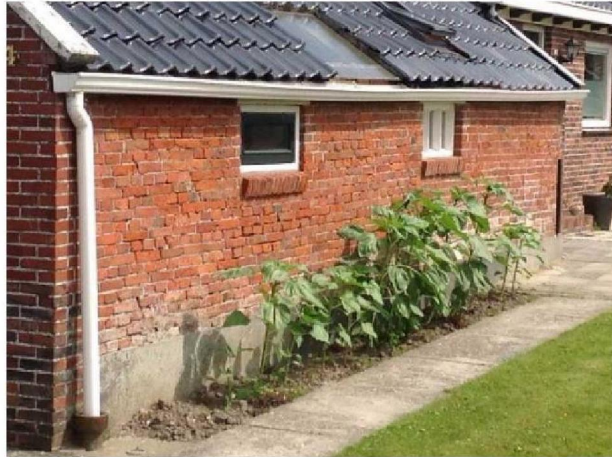
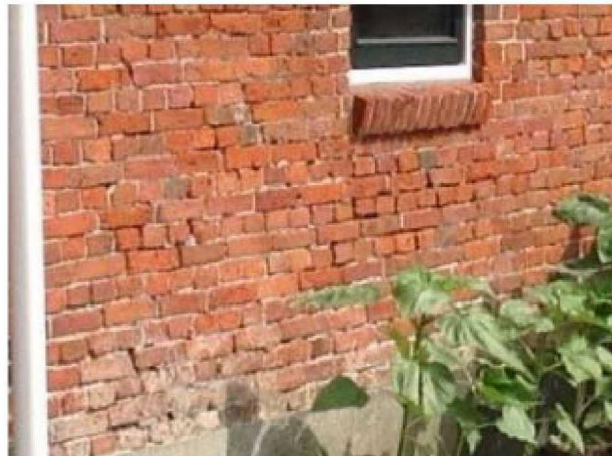
Extensive lack of mortar ✓ Further investigation

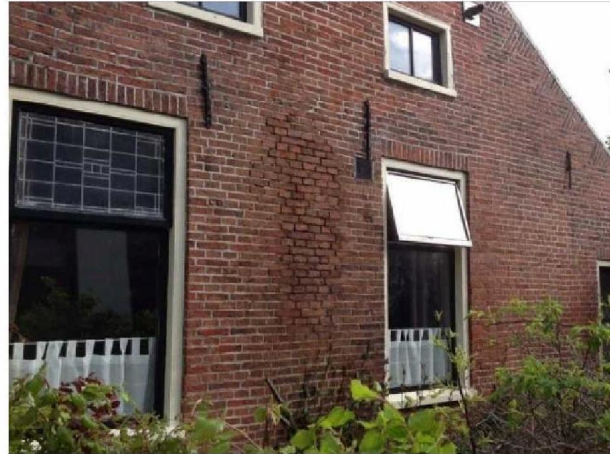
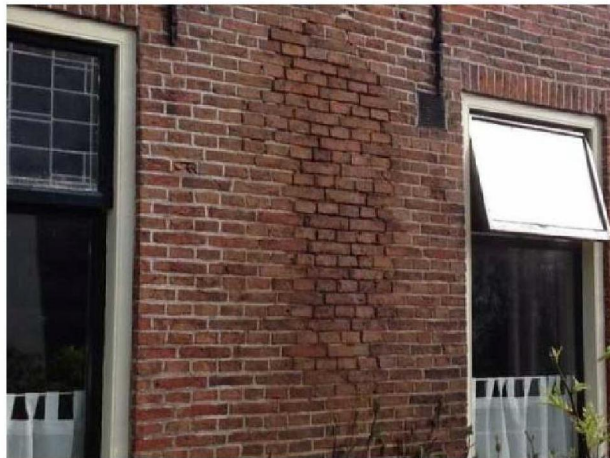
Large parts of the wall joints are missing.

The lack of mortar could reduce the bearing/shear capacity of the wall. See the manual for a description of the different types of mortar.

Extensive lack of mortar ✓ Further investigation

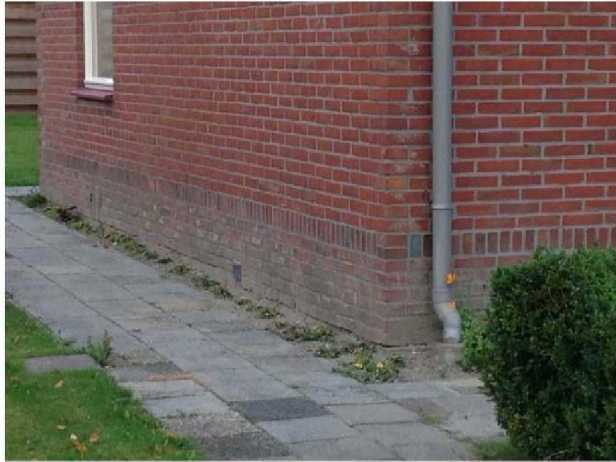
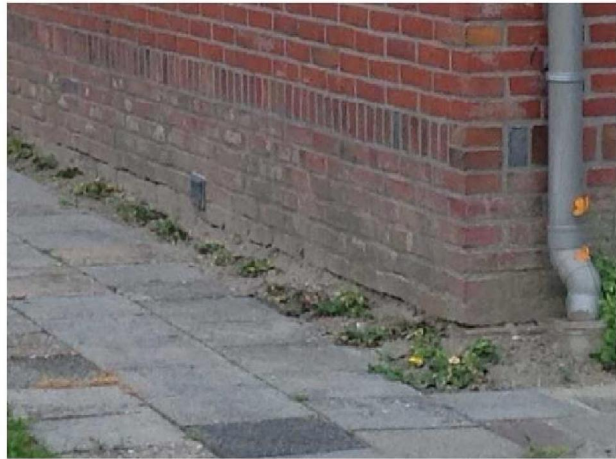
Large part of the wall joints are missing

The lack of mortar could reduce the bearing/shear capacity of the wall. See the manual for a description of the different types of mortar.

Extensive lack of mortar ✓ Further investigation

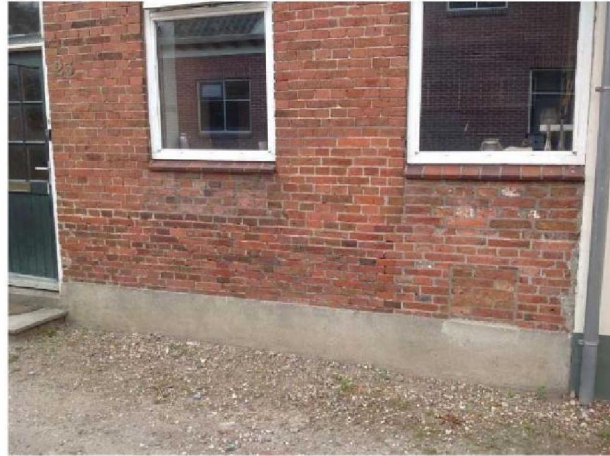
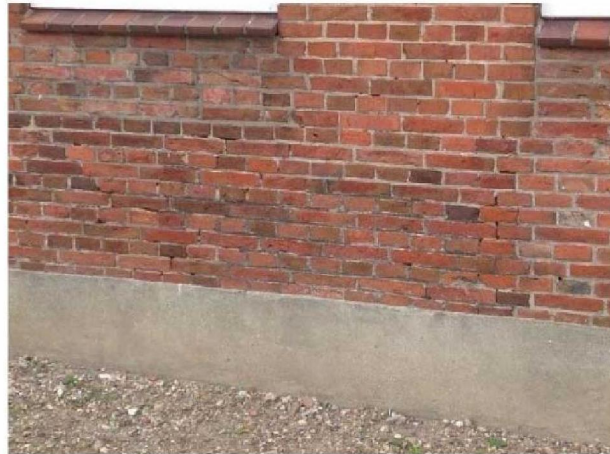
Joints are missing in the left facade at ground level

The lack of mortar could reduce the bearing/shear capacity of the wall. See the manual for a description of the different types of mortar.

Extensive lack of mortar ✓ No action

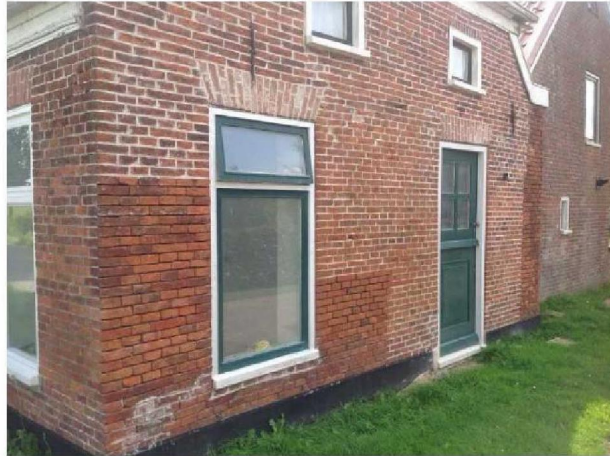
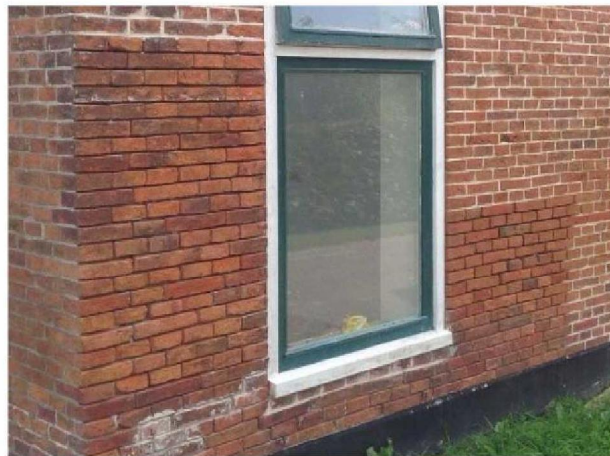
Small parts of the wall joints are missing

The lack of mortar could reduce the bearing/shear capacity of the wall. See the manual for a description of the different types of mortar.

Extensive lack of mortar

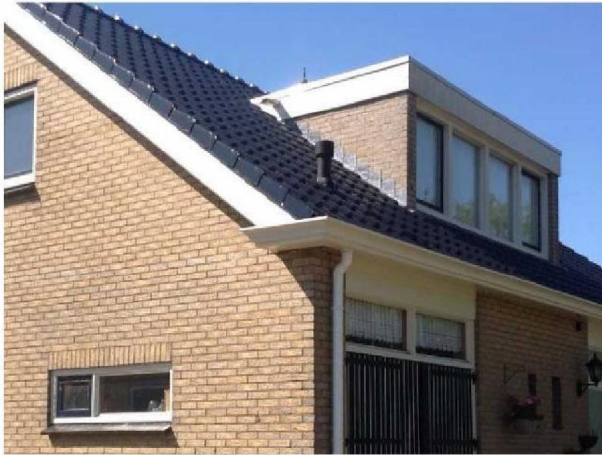
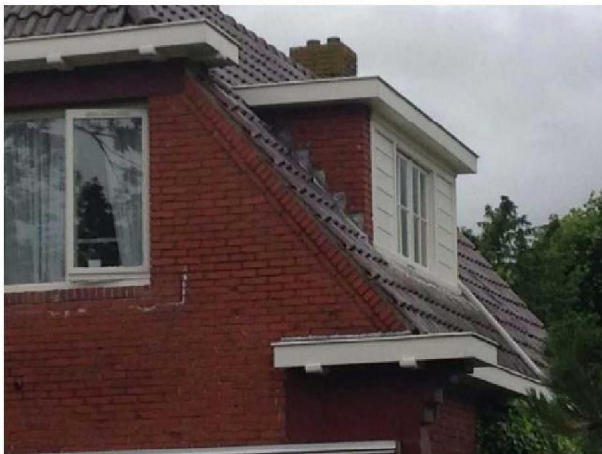
HRBE 11 - Masonry Dormers

Masonry Dormer

Masonry dormer observed, possibly supported on timber frame. There is no damage observed on the dormer.

Further investigation is required to establish the bearing frame of the masonry dormer.

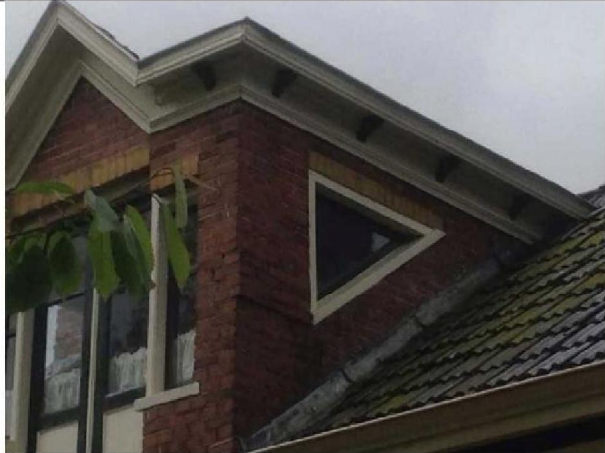
HRBE 11 - Masonry Dormers

Masonry Dormer

There are large cracks observed on both sides of the masonry dormer.

Further investigation is required to establish the bearing frame and the vulnerability of the masonry dormer.
