Handbook: 1. Structural Upgrading - Version 0.0

Process step: 2. RVS

Engineering Inspection Manual RVS

Building type: CC1b
NAM ref: EP201311204127

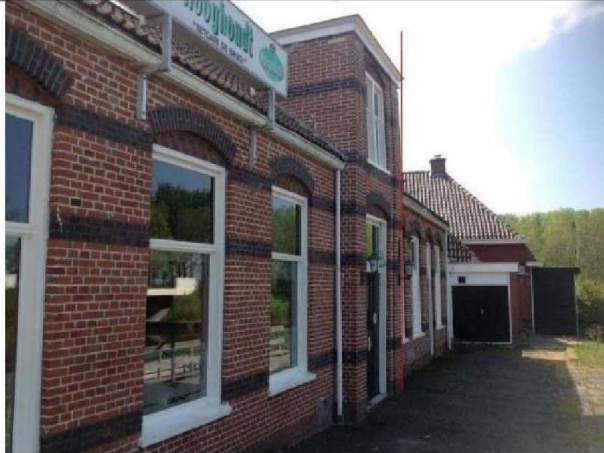
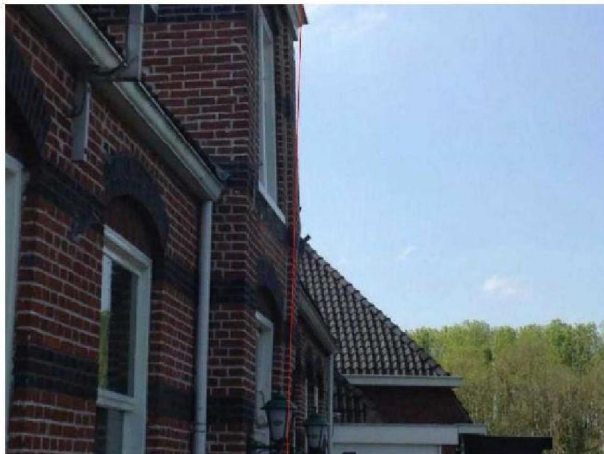
HRBE 11 - Masonry Dormers

Masonry Dormer

Major out-of-plane issues observed on masonry dormer. The dormer is approximately 5 cm out of plane.

Further investigation is required to establish the bearing frame and the vulnerability of the masonry dormer.

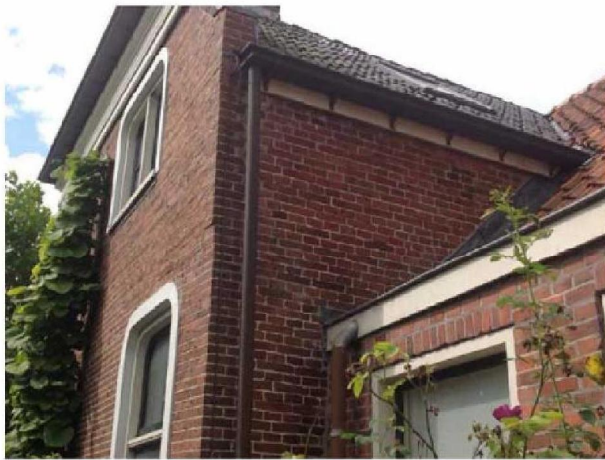
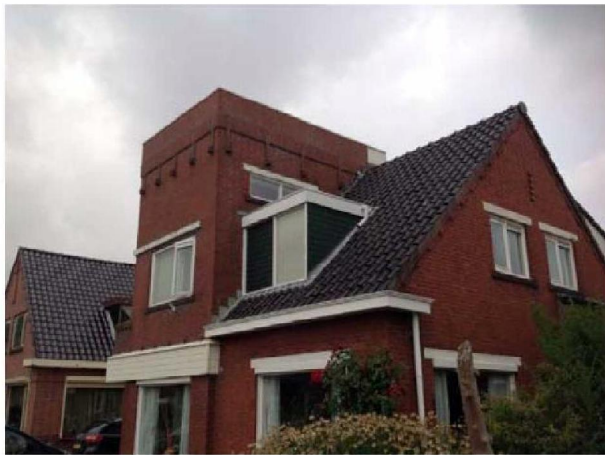
HRBE 11 – Not Masonry Dormers

<i>Masonry Dormer</i>	x	-
<i>Roof/building extension</i>	√	-

Data Characteristics:
 In the pictures we see a larger building extension. This shouldn't be called a masonry dormer, but just a building extension. In this case, the loads of sidewalls are probably distributed to the foundation by bearing walls.

This building element should not be reported as a masonry dormer. If there is damage observed (for example wall cracks in one of the sidewalls), this can be reported under HRBE 3: Wall cracks.

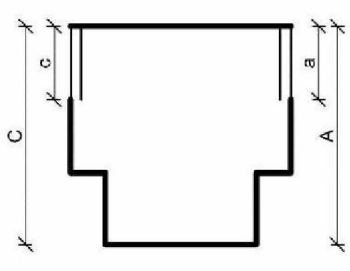
Solid 220mm / Cavity

Cavity wall present	✓	-														
Inner leaf	100	-															
Outer leaf	100	-															
Total wall thickness	250	-															
Wall ties	x	-															
<p><i>Data Characteristics:</i></p> <p>The majority of the external walls are walls with a thickness of 220mm, but a small part of the walls consist of solid walls with a thickness of 100mm.</p>																	
<p><i>Inspector Comment:</i></p> <p>Option 1:</p> <p>-</p> <p>Option 2:</p> <p>Due to differences in masonry patterns, cavity wall has been selected as the most conservative.</p>																	
<p><i>Note for inspector:</i></p> <p>It has been assumed that the threshold value to be conservative is when 25% of the walls in any direction are solid 100mm walls. The weight of structure is not underestimated by adopting 100mm walls and the shear area of the masonry is not overestimated.</p>

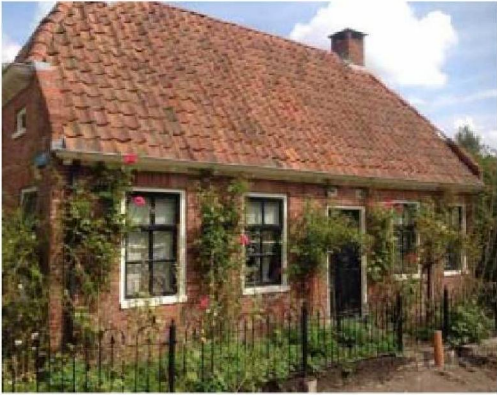
Walls with stretchers only, building year before 1920

If the masonry observed is original, we can assume that the masonry visible from outside is the bearing wall, consisting of only a single wythe. If we see a significant space between the front of the façade and the front of the window frame (reveal depth/in dutch: “negge”), we assume that a backwall of shiners is present to connect the window frame. We select cavity wall as conservative assumption (without wall ties)

<i>Cavity wall present</i> ✓ - <i>Inner leaf</i> 100mm - <i>Outer leaf</i> 100mm - <i>Total wall thickness</i> 250mm - <i>Wall ties</i> x -
	<i>Data Characteristics:</i> <ul style="list-style-type: none"> • Building year older than 1920 • A significant space between the front of the façade and the front of the window frame is observed ~50mm. • The masonry observed on all facades is running bond (only stretchers) and this is assumed to be original.
	<i>Inspector Comment:</i> -
	<i>Note for inspector:</i> We assume that a backwall of shiners is present. The weight of the rowlock backwall is taken into account by selecting a cavity wall.

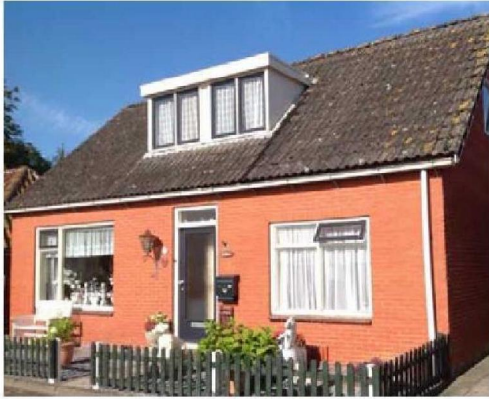
Walls with stretchers only, building year before 1920

<i>Cavity wall present</i>	✓	-
<i>Inner leaf</i>	100mm	-
<i>Outer leaf</i>	100mm	-
<i>Total wall thickness</i>	250mm	-
<i>Wall ties</i>	x	-

- Building year older than 1920
- The masonry observed on all facades is running bond (only stretchers). This is assumed to be **not original**.

Possible there has been a rebuild process of the facades. Cavity wall and year of construction (1900), to be further investigated.

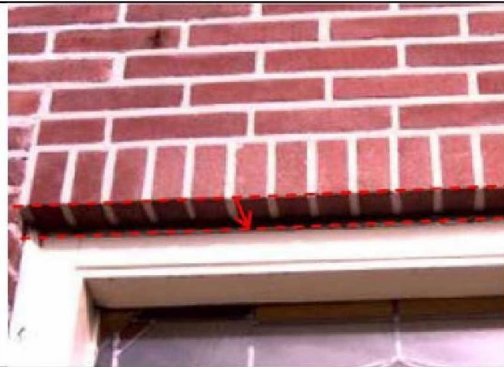
Reveal depth

Space between the front of the façade and the front of the windowframe: (see picture)
Dutch: (negge /neggemaat)

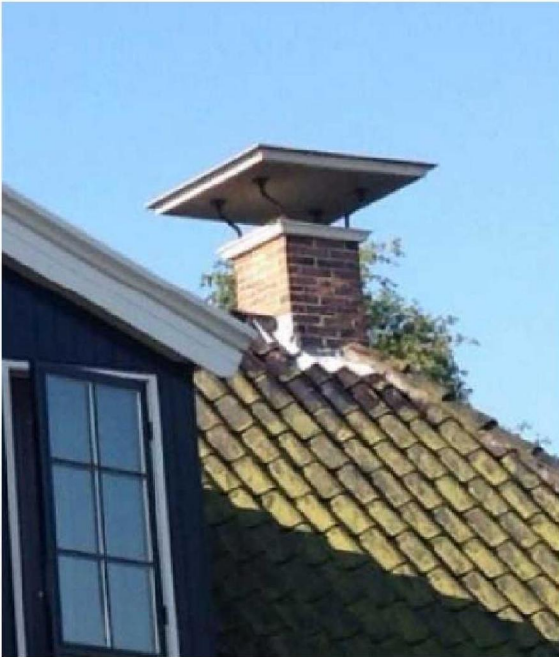
Chimney with caps

<table><tr> <td><i>HRBE 7</i></td> <td>✓</td> <td>Further investigations</td> </tr></table>

During the inspection caps of various types and materials may be found over masonry chimneys. If the weight of the caps is comparable to the weight of two or more layers of masonry, it may be un-conservative to ignore the presence of the cap when calculating the slenderness ratio of the chimney during the assessment of HRBE 7.

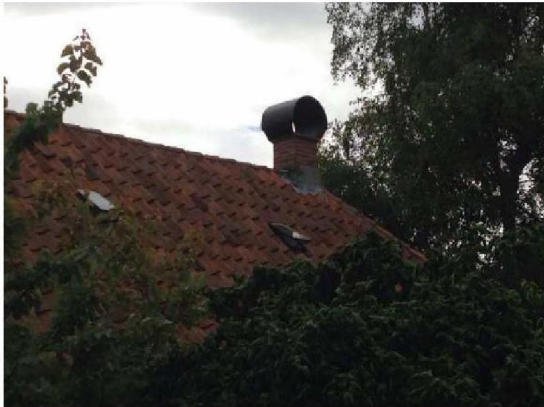
Chimney with caps

HRBE 7	X	-
HRBE		
13_ornament	X	-
None	X	-

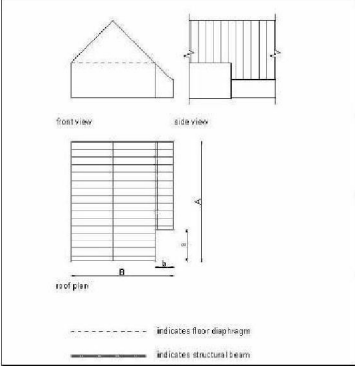
<p>SI-3</p>

<p>front view side view</p> <p>roof plan</p> <p>----- indicates floor diaphragm _____ indicates structural beam</p>	<table border="1"> <tr> <td>H Irregularity</td> <td>✓</td> <td>L-shape</td> </tr> <tr> <td>V Irregularity</td> <td>✓</td> <td>Others</td> </tr> <tr> <td>S Irregularity</td> <td>X</td> <td>-</td> </tr> </table> <p>Data Characteristics: -</p> <p>Surveyor Comment: *comments on the data measured are expected</p> <p>Engineer Comment: Potential vulnerability: Possible differences in the resisting structural systems.</p>	H Irregularity	✓	L-shape	V Irregularity	✓	Others	S Irregularity	X	-
H Irregularity	✓	L-shape										
V Irregularity	✓	Others										
S Irregularity	X	-										
		<p>SI-4</p>

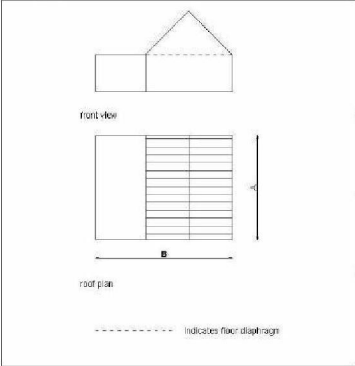
<p>front view</p> <p>roof plan</p> <p>----- indicates floor diaphragm</p>	<table border="1"> <tr> <td>H Irregularity</td> <td>X</td> <td>-</td> </tr> <tr> <td>V Irregularity</td> <td>X</td> <td>-</td> </tr> <tr> <td>S Irregularity</td> <td>X</td> <td>-</td> </tr> </table> <p>Data Characteristics: - Full building lengths</p> <p>Surveyor Comment: *comments on the data measured are expected</p> <p>Engineer Comment: Potential vulnerability: Possible interaction of adjacent structures.</p>	H Irregularity	X	-	V Irregularity	X	-	S Irregularity	X	-

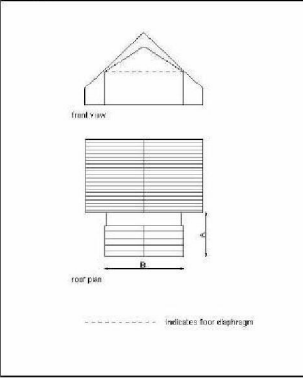
<p>SI-7</p>

<table><tr> <td>H Irregularity</td> <td>X</td> <td>Weak link</td> </tr><tr> <td>V Irregularity</td> <td>X</td> <td>Others</td> </tr></table>
